Elodea: A New Threat to Alaskan Waters

An overview of 2011 management activities in Interior Alaska

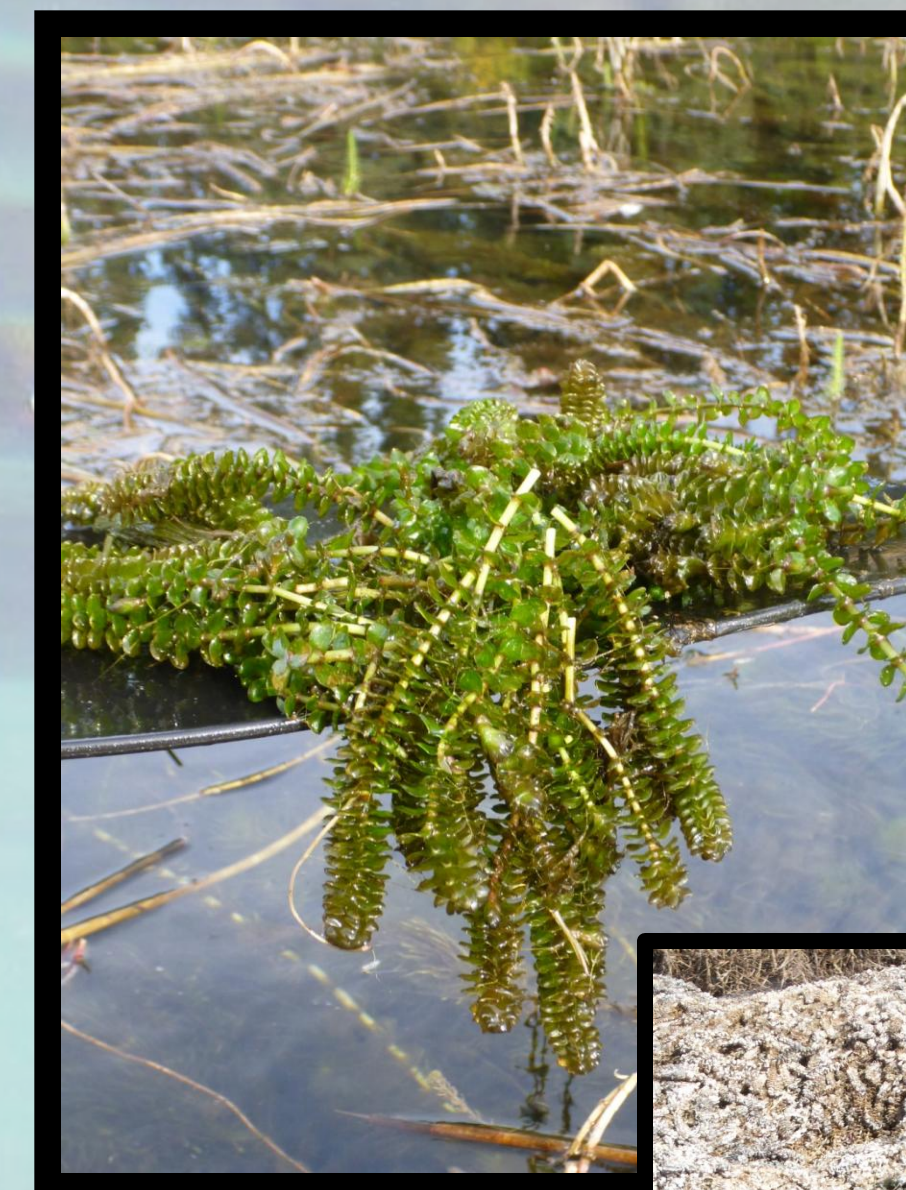
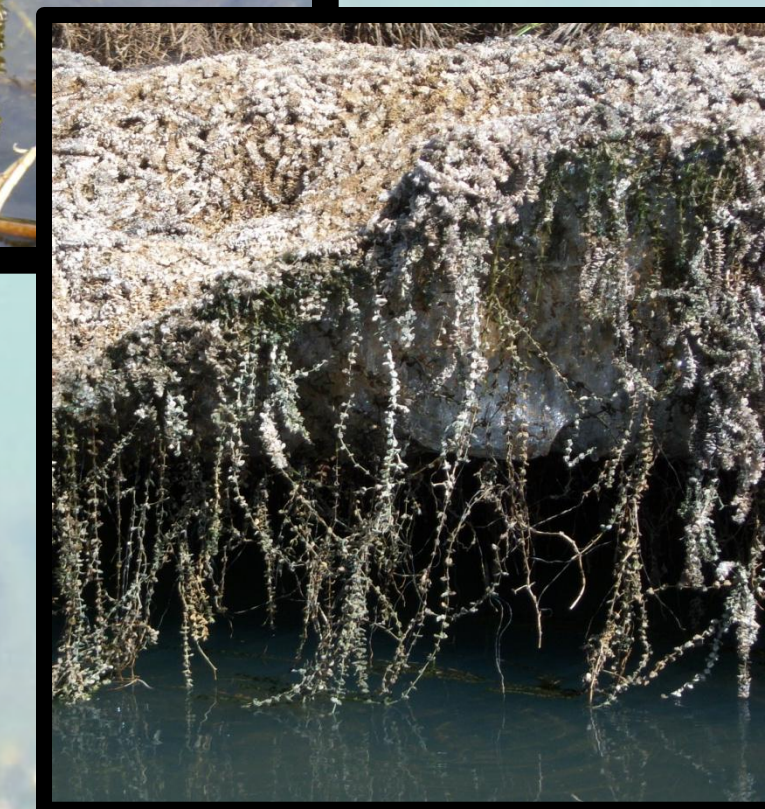
Left:
Elodea
caught on
a canoe
paddle
Below:
Spring ice
covered in
Elodea

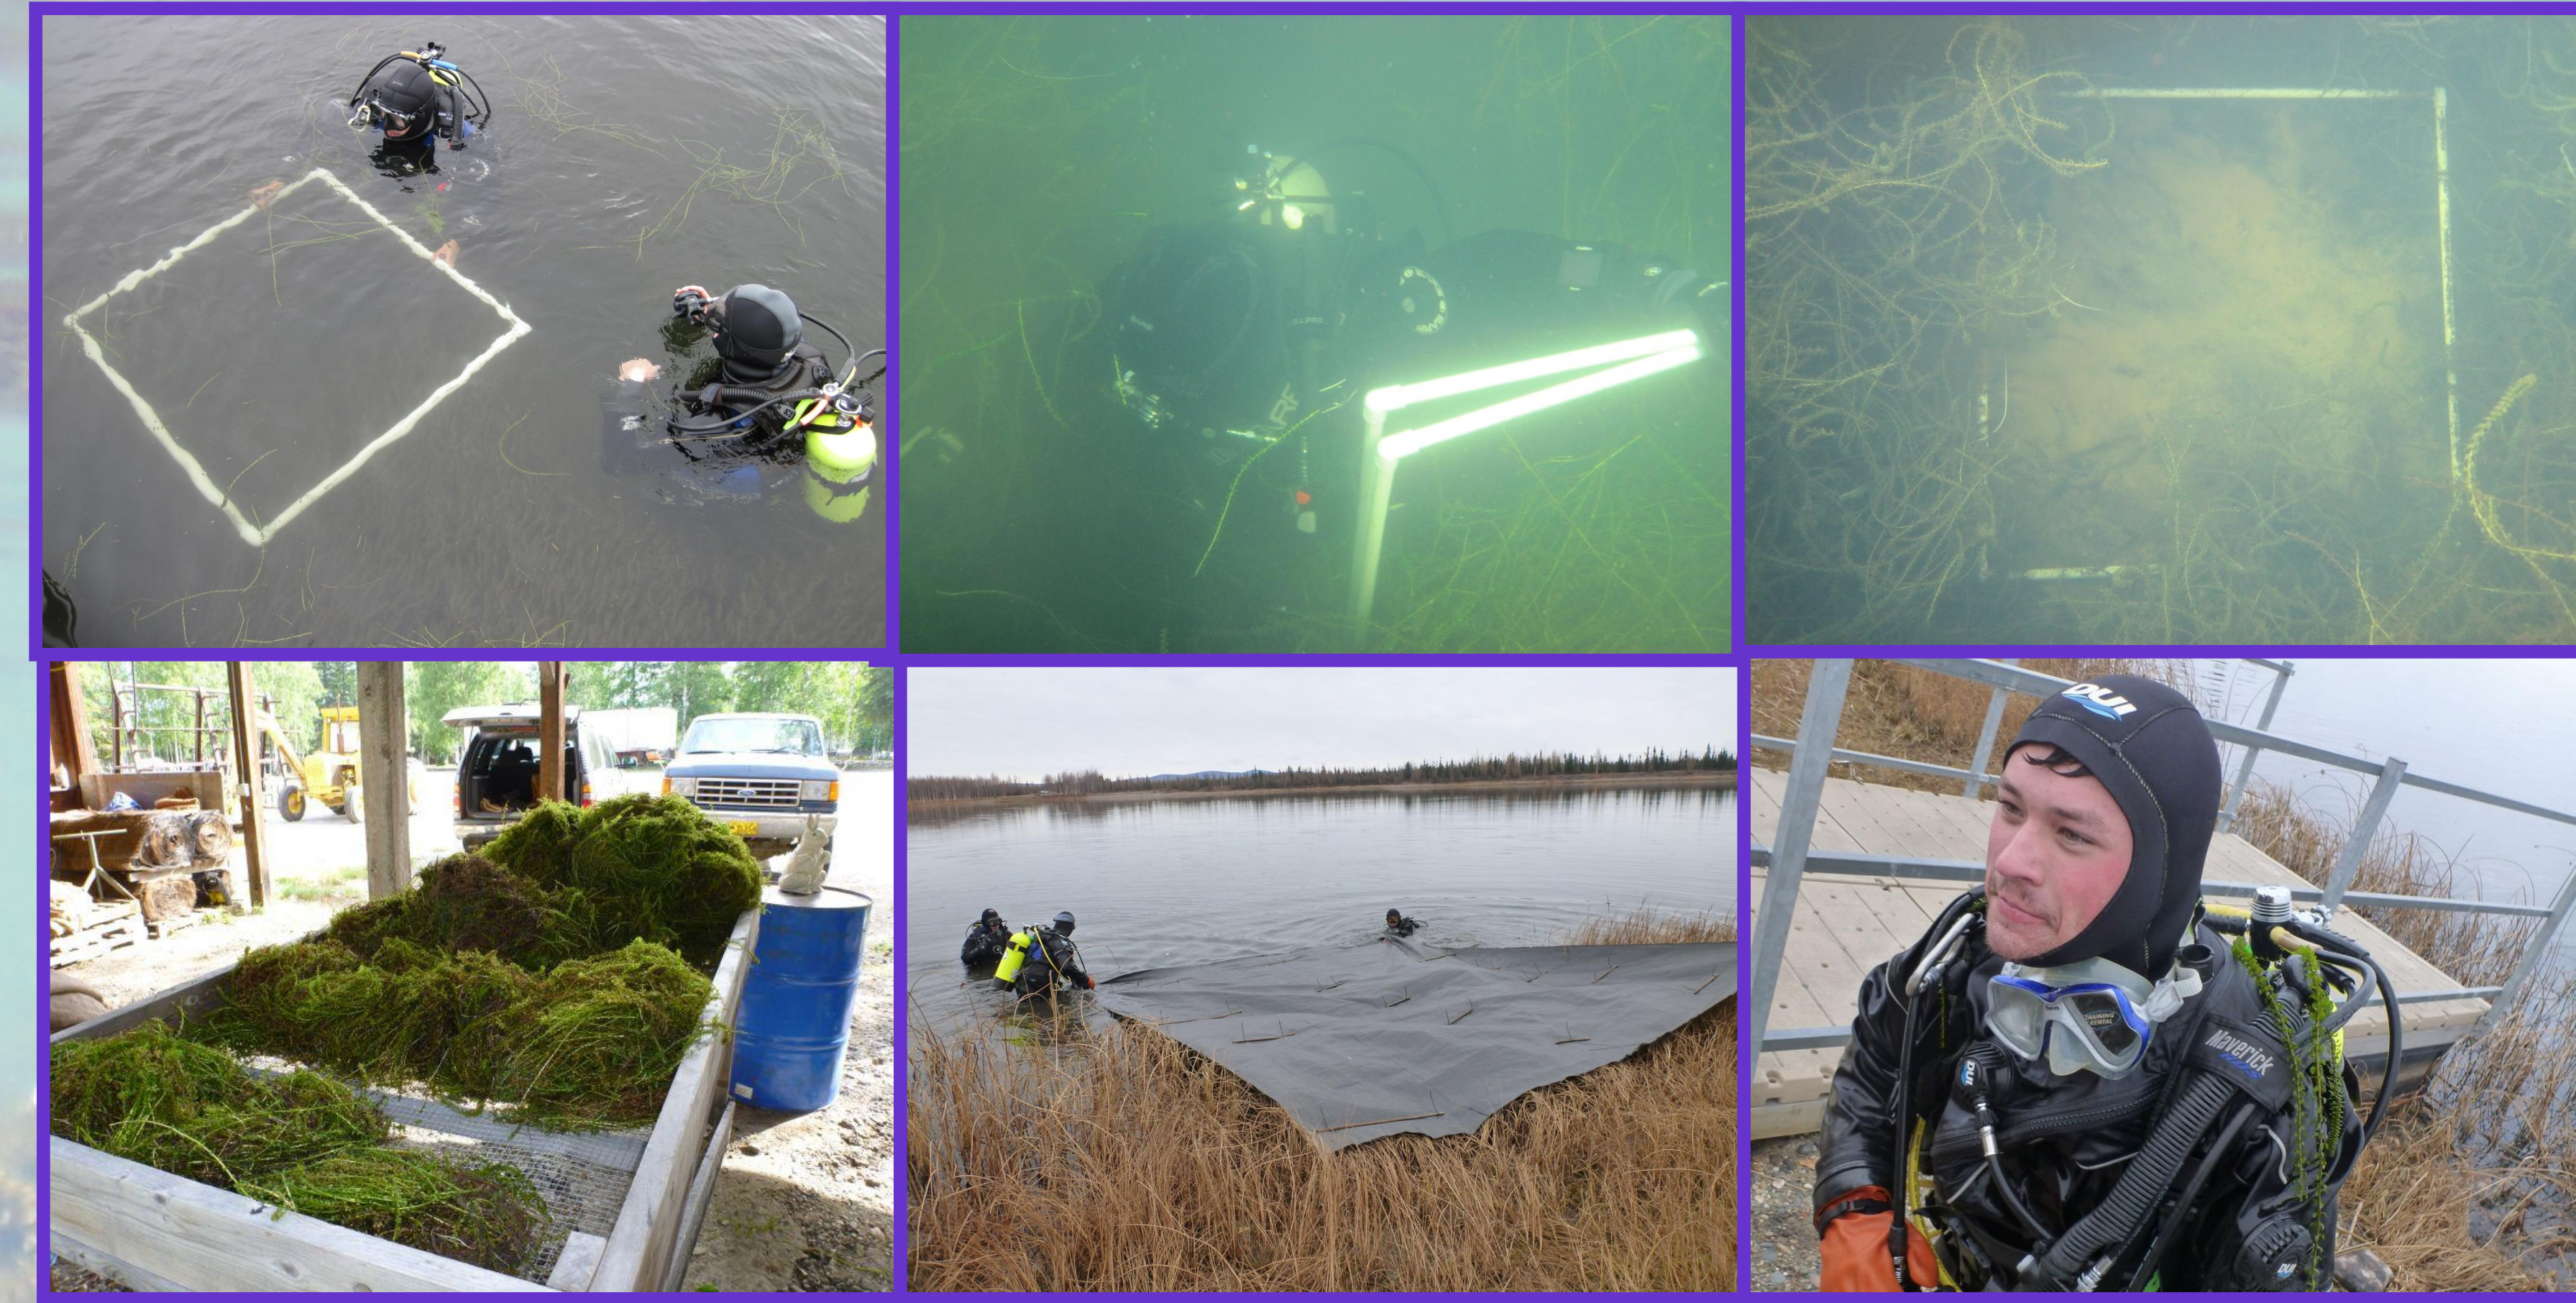
Elodea nuttallii infestations in Fairbanks, AK

Survey locations not pictured: Harding Lake, Birch Lake, Quartz Lake, Clearwater River, Tanana River, Birch Creek, Chatanika River (no Elodea found at any of these sites)
